December 21, 1962
DMIC Memorandum 161

ELECTRON MICROSCOPIC FRACTOGRAPHY

DEFENSE METALS INFORMATION CENTER
BATTELLE MEMORIAL INSTITUTE
COLUMBUS 1, OHIO

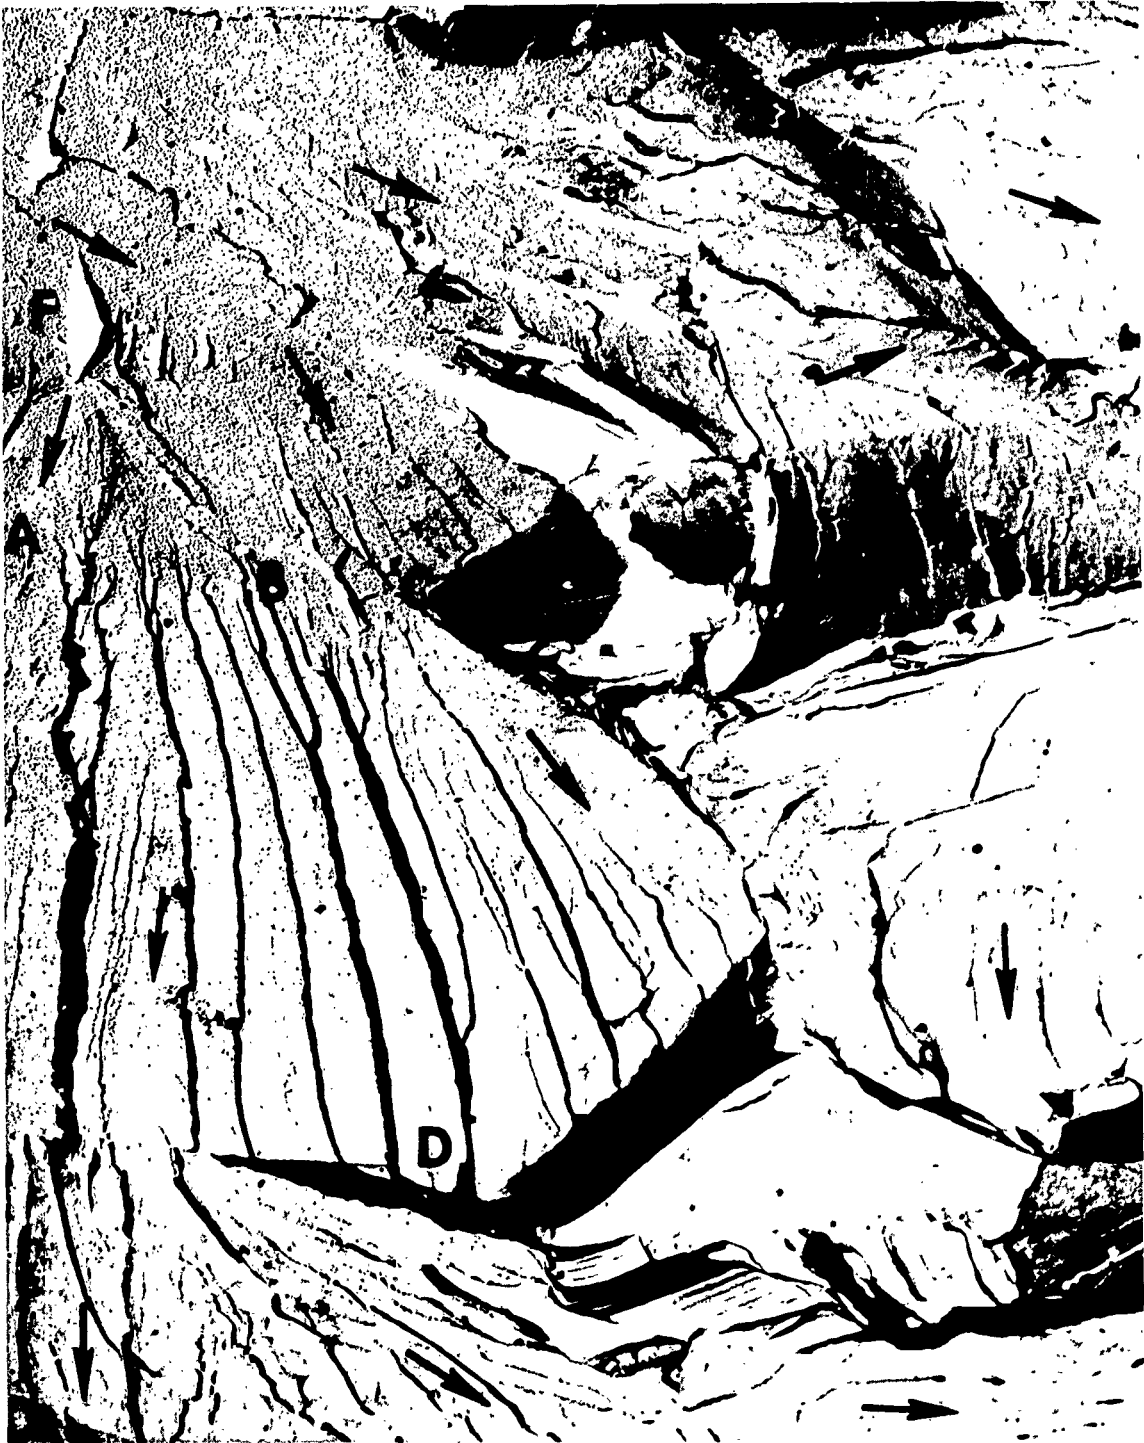
6,000X

- (a) Change in orientation of the cleavage plane in crossing grain boundaries (D)
- (b) Indications of the local direction of crack propagation by the river markings on the cleavage facets (arrows)
- (c) Variability of the direction of crack propagation from grain to grain
- (d) Formation of small cleavage "tongues" which are due to the cleavage of deformation twins formed by plastic deformation at the tip of the propagating crack (F).

FIGURE 6. CLEAVAGE FRACTURE IN IRON BROKEN AT 78 K⁽¹³⁾

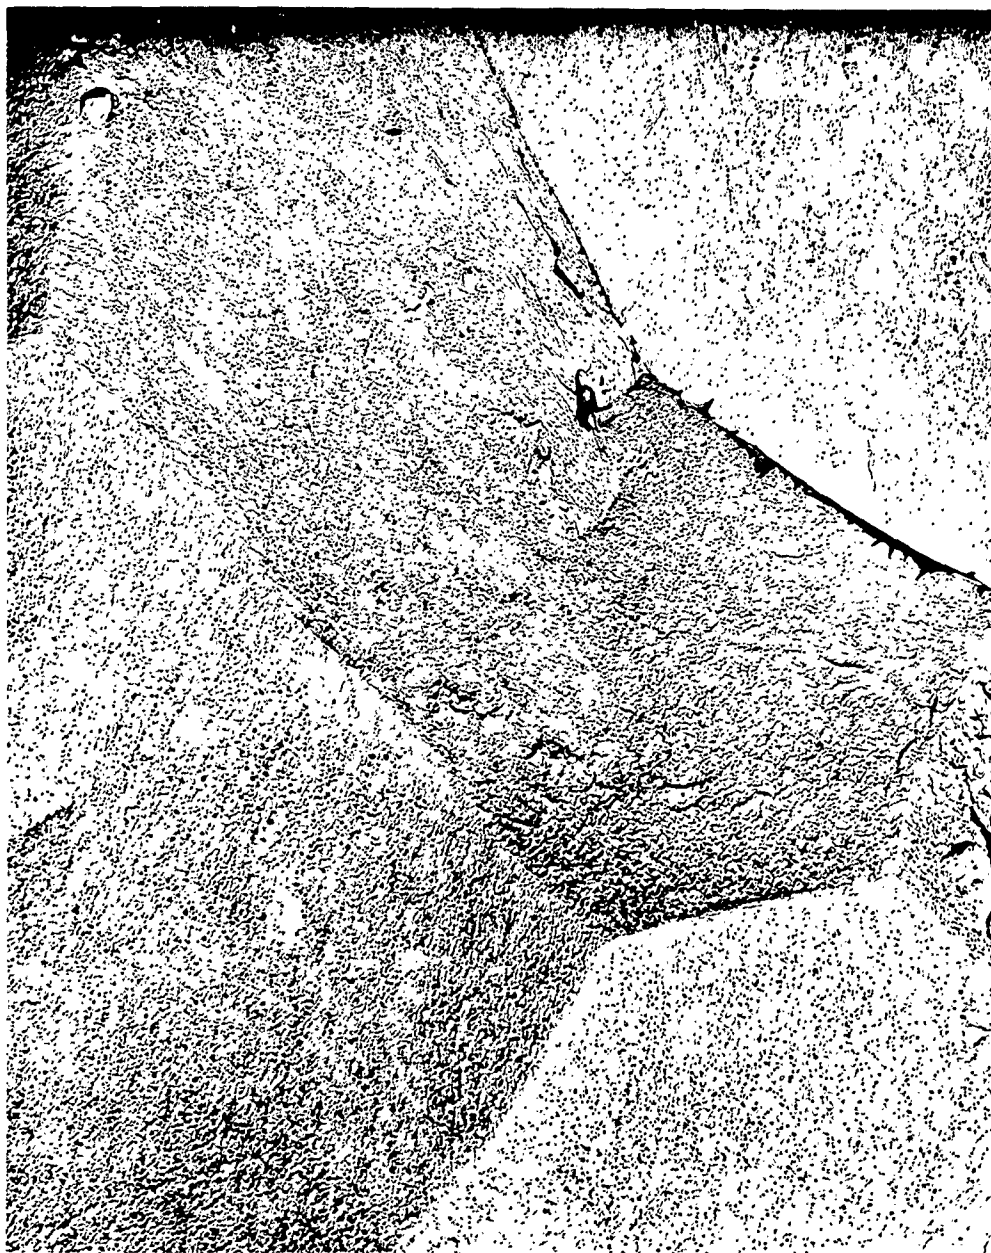
7,500X, reduced by 25%

Figures 9, 10, and 11 are fractographs of a hydrogen-induced brittle fracture, a stress-corrosion crack, and a quench crack, respectively.(13) The marked similarity among the three figures is immediately apparent. All three are definitely intergranular with no visible signs of ductility. A specimen which had been cadmium plated and stressed at a temperature above the melting point of cadmium also showed a similar fracture appearance.(9) The investigators working in the field of electron microfractography generally agree that they cannot distinguish among these types of fracture with any degree of certainty(5,9,13,16,29). However, they are optimistic that some distinguishing features will be found. Perhaps analysis of the "hairlines" which appear on the grain-boundary surfaces will provide such a key. On the other hand, the similarity in fracture appearance may indicate a similarity

FIGURE 9. HYDROGEN-INDUCED BRITTLE FRACTURE IN AISI 4340 STEEL, ULTIMATE TENSILE STRENGTH, 265 KSI; APPLIED STRESS, 30 KSI; CATHODIC CHARGED

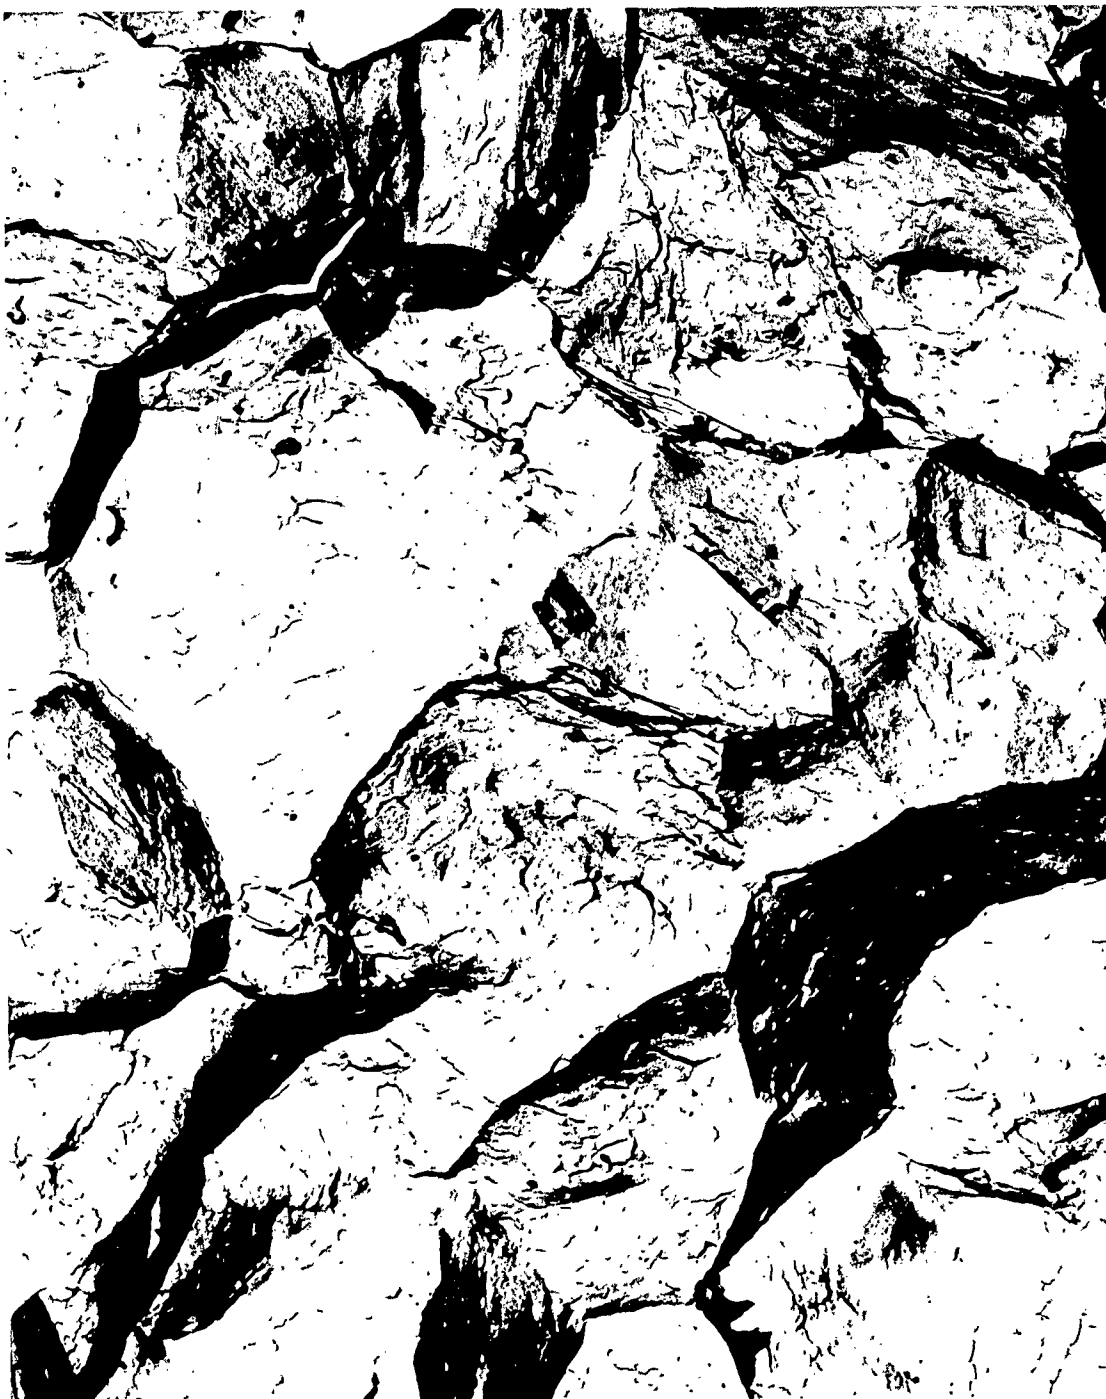
5,000X

FIGURE 10. STRESS-CORROSION CRACK IN AISI 4340 STEEL(13)
